LOCALIZED CORROSION INDUCED IN
GRAPHITE/ALUMINUM METAL-MATRIX COMPOSITES
BY RESIDUAL MICROSTRUCTURAL CHLORIDE

L.H. Hihara and R.M. Latanision

Technical Report
to
Office of Naval Research
Grant No. N00014-89-J-1588

February 1990-

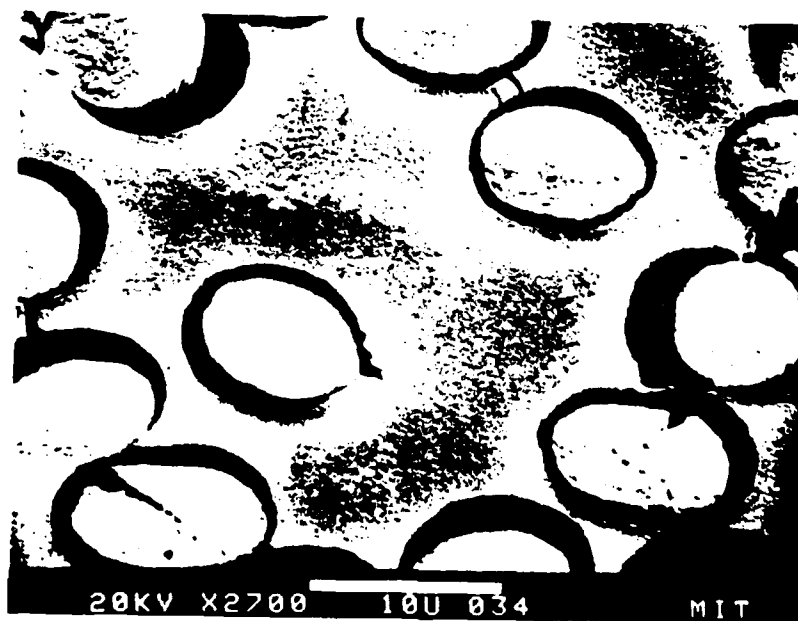
Figure 14: SEM micrograph showing crevices along the perimeters of graphite fibers in a planar G/6061-T6 Al MMC six-ply plate electrode that was anodically polarized at 2.0 V_{SCE} for 3.2 h in deaerated 0.5 M Na₂SO₄ of pH 7 at 30°C. The formation of crevices was caused by CO₂ evolution, resulting from the oxidation of graphite.

Figure 14 shows crevices that formed along perimeters of graphite fibers during anodic polarization at 2.0 V_{SCE} for 3.2 hours at 30°C in deaerated 0.5 M Na₂SO₄.

Finally, comments are due regarding crevices that formed along fiber perimeters (Figure 14) which could be mistaken for dissolution of fiber-matrix interfaces. The crevices formed during anodic polarization in 0.5 M Na₂SO₄. The corrosion morphology shown in Figure 14 is identical to that seen in graphite/epoxy composites¹⁰. Epoxy is unaffected by anodic polarization whereas the graphite fibers are oxidized primarily to CO₂¹⁰. Since the Al matrix in G/6061-T6 Al MMCs should passivate near fiber-matrix interfaces (where microstructural chloride is rarely found⁹), the corrosion morphology is expected to be similar to that of graphite/epoxy composites. Thus, the apparent interfacial dissolution was actually the result of graphite oxidation.
